NTSB National Transportation Safety Board

Office of Highway Safety

Girder Failure

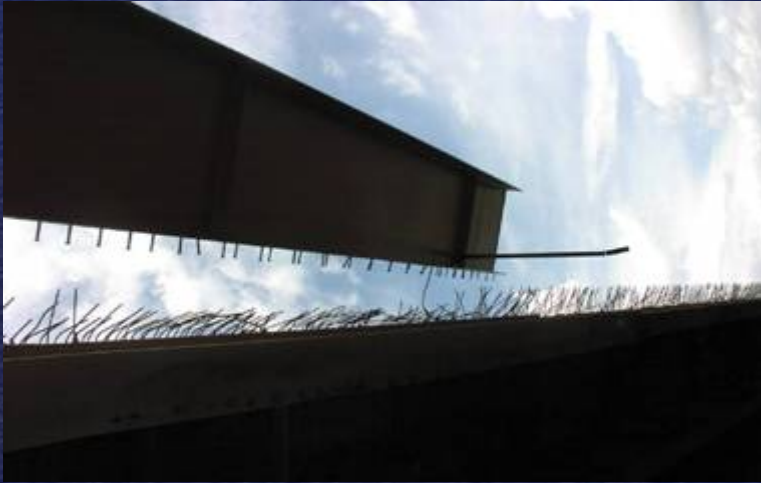
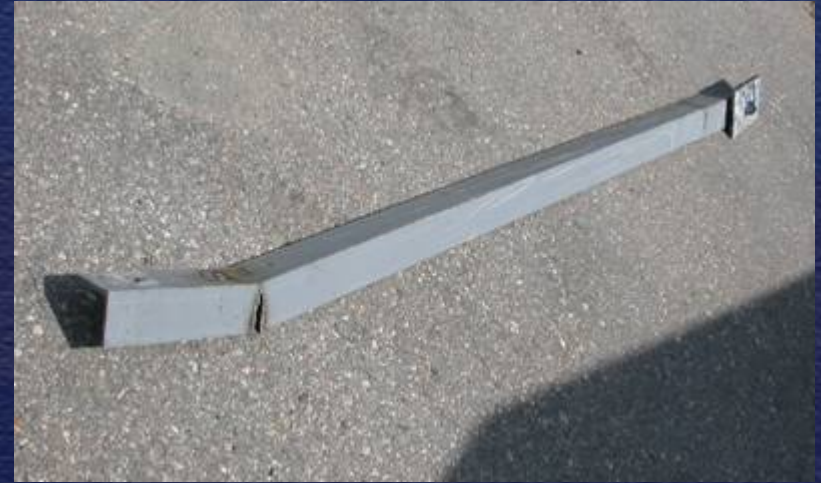
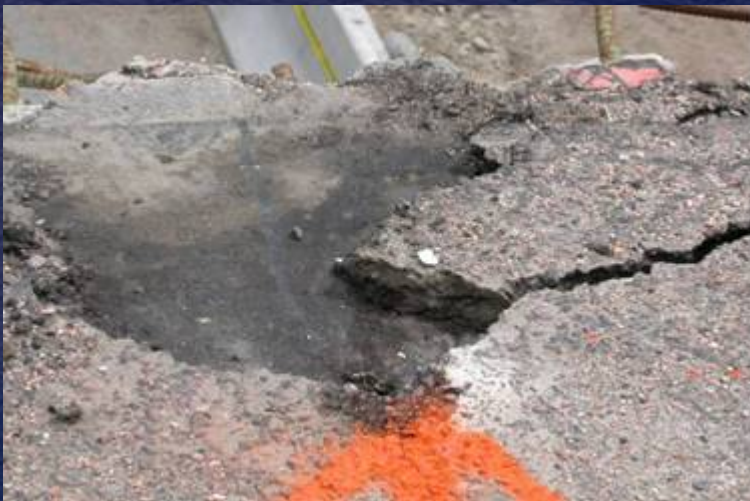
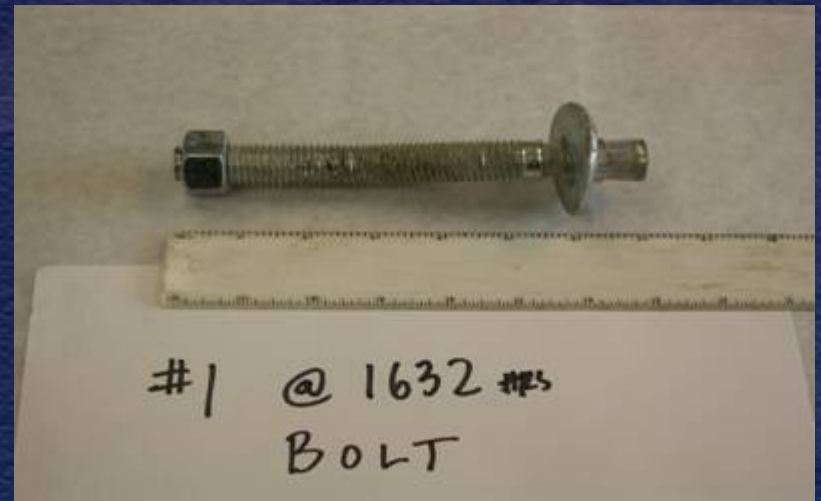
Lateral Brace 5 and Bolt

- Out-of-plumb girder
- Lateral braces not flush with existing bridge deck
- Bolts not installed to manufacturer installation requirements
- Diameter of hole larger than diameter of bolt

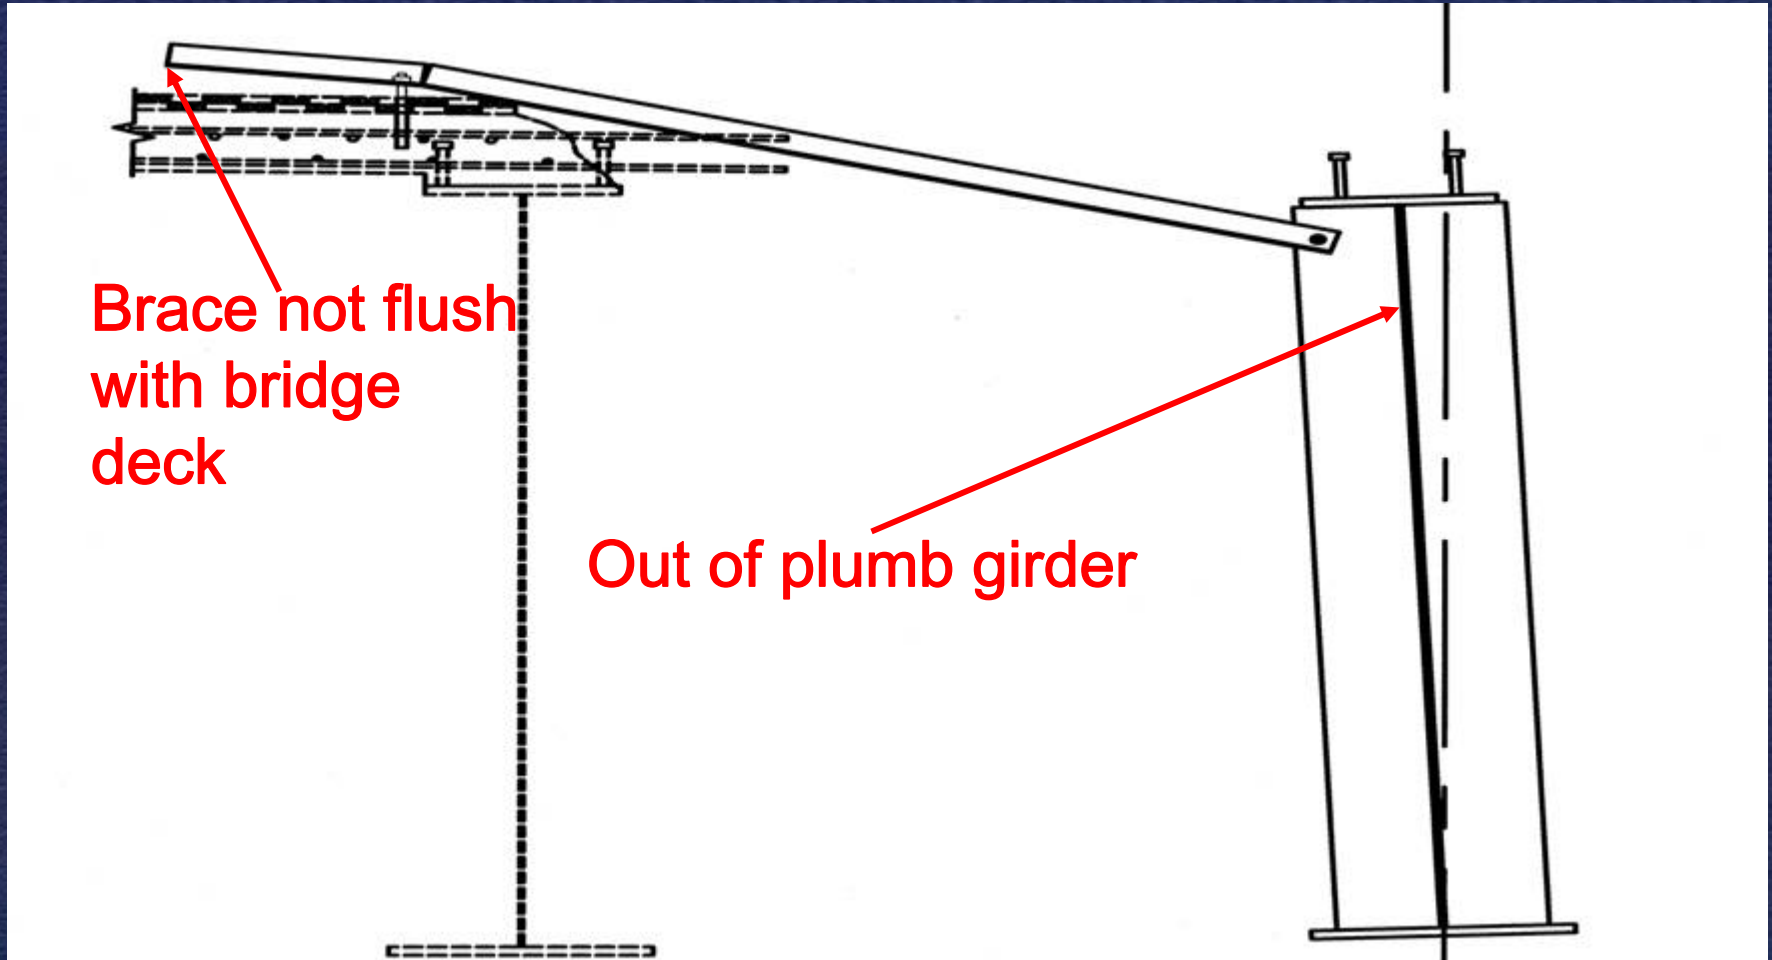
Improper Construction Methods

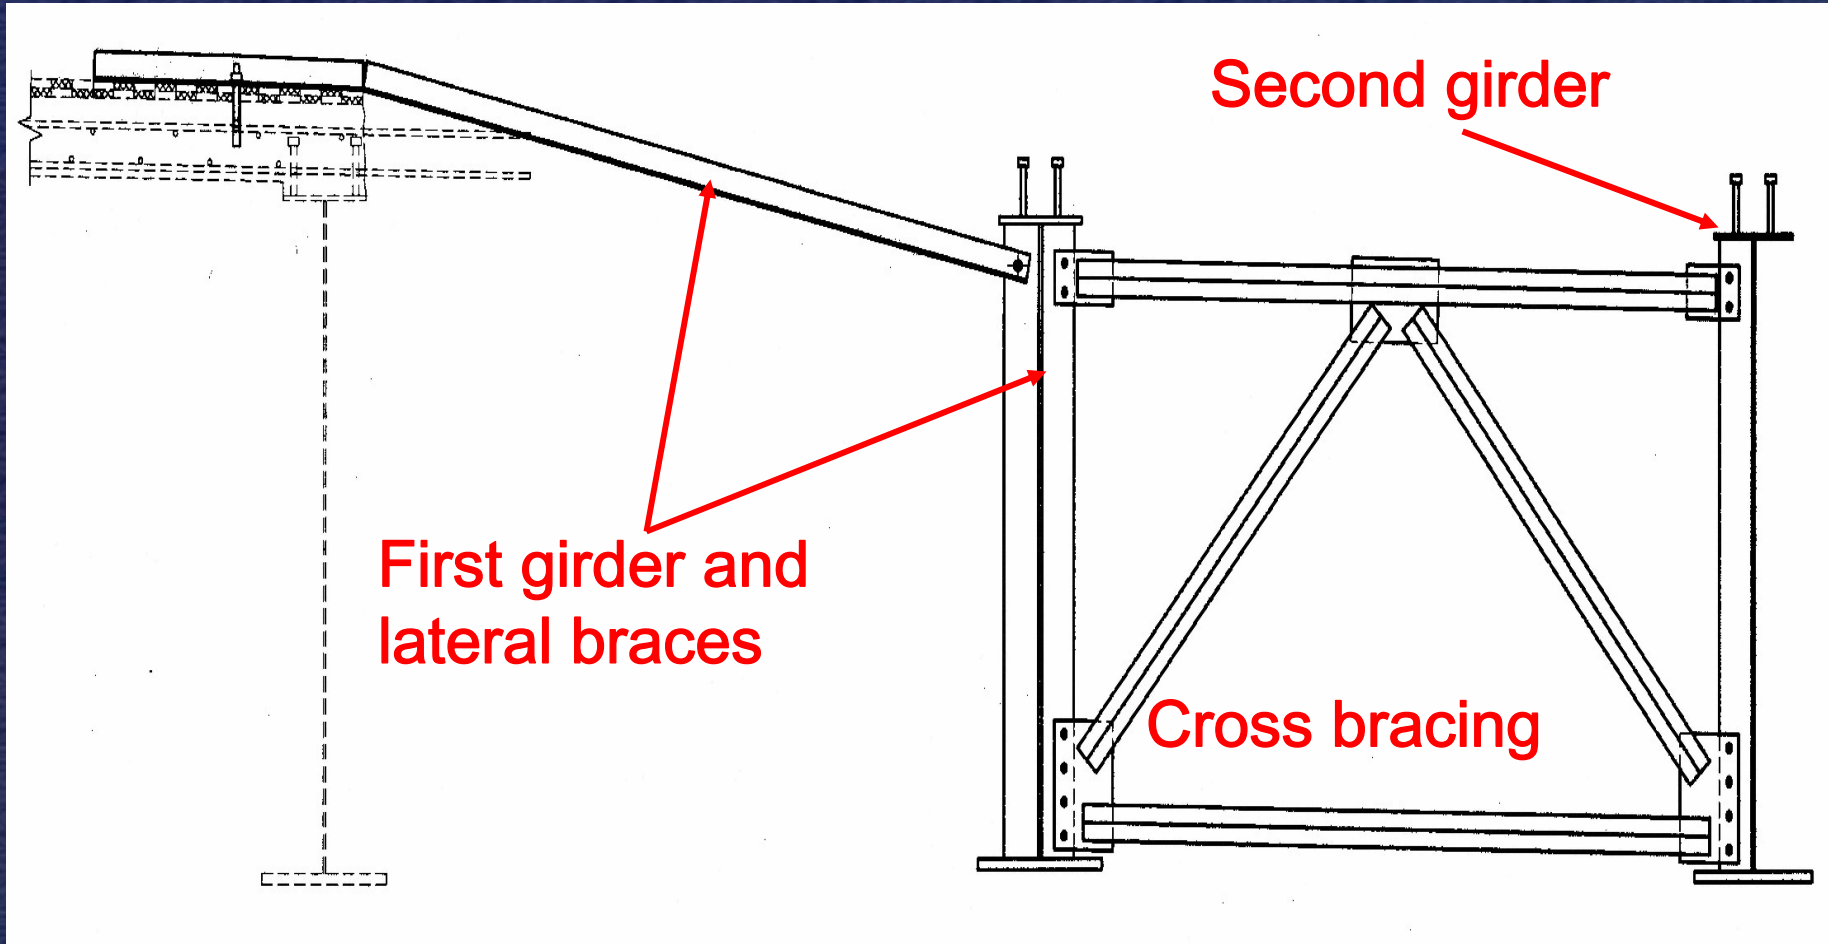
Install Two Girders

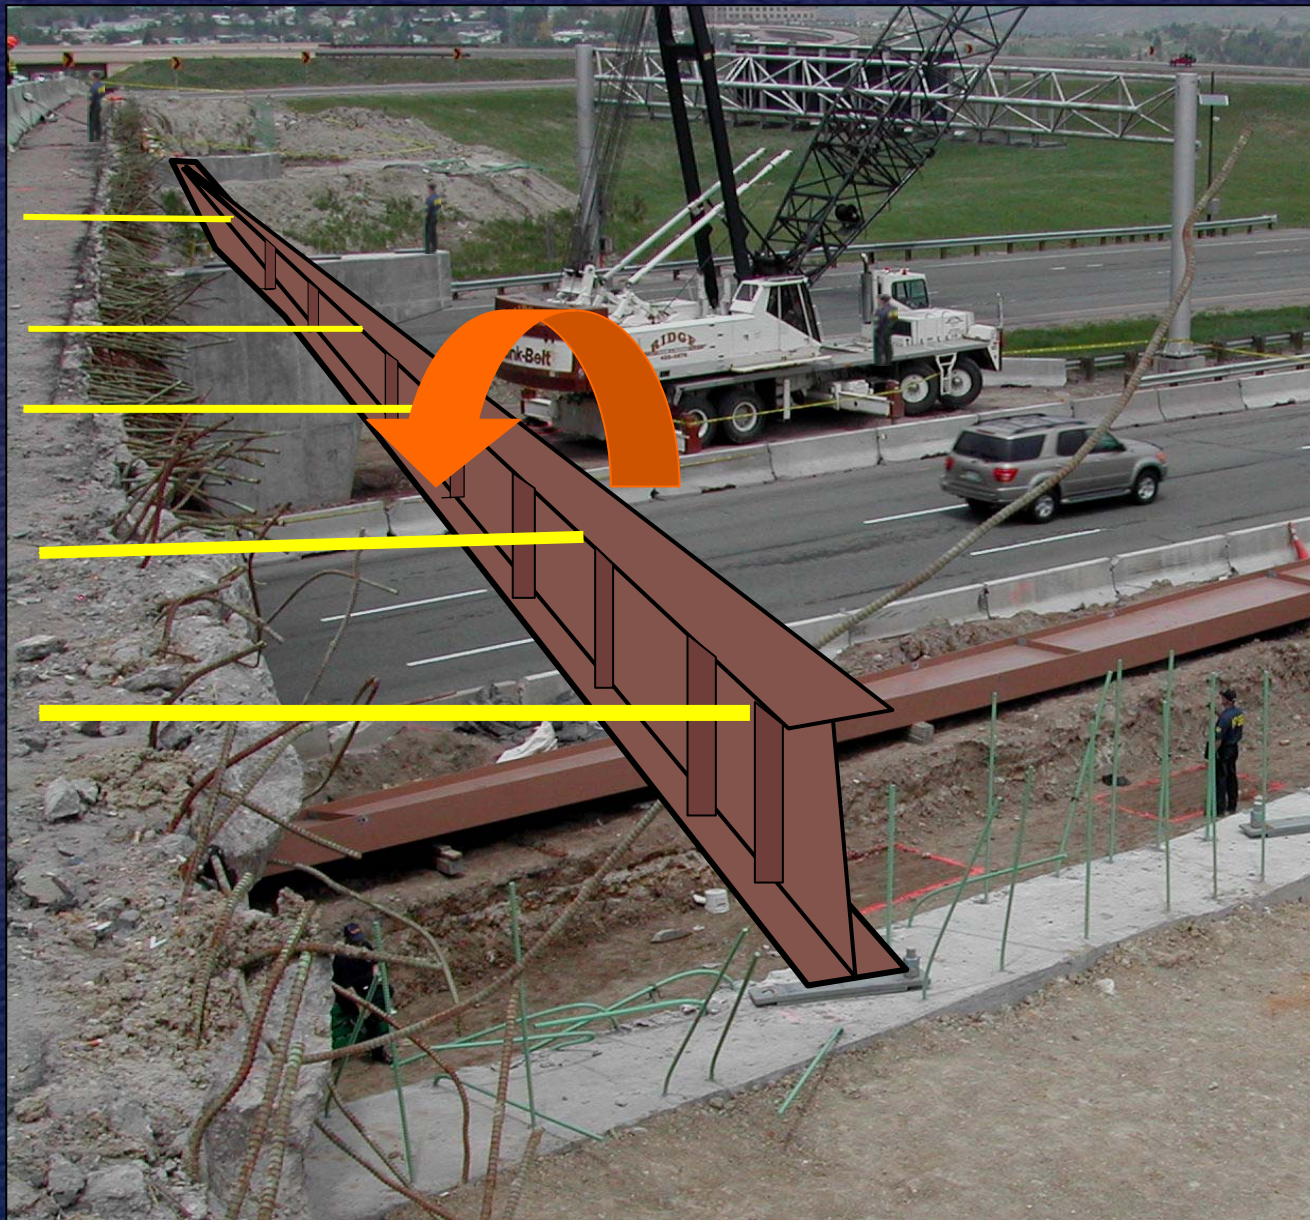
- FHWA Turner-Fairbank Highway Research Center
- Various combinations of braces were removed
- Brace 2 was the most critical to providing stability
